**Flood Control Project Maintenance  
Levee Inspections**

## Maintenance Issue Types Only, Levee Inspection Report By Mile - Spring 2018

### Levee District No. 0001 (Glenn County)

Waterway	Bank	Unit Miles	Inspection Start/End	Inspector
Unit No. 01 Sacramento River	Right	12.23	03/08/2018 03/08/2018	Bob Duffey

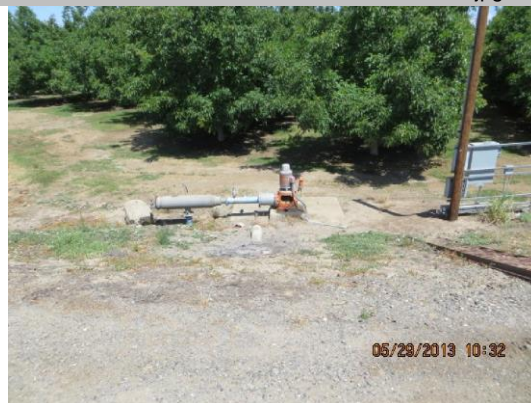
Photo 1 of 3 : UCIP\_SP\_2018\_14332\_23582.jpg

LM Start	2.22	Rating **	M	Issue No.	402
LM End	2.22	Issue Type +	Ma	Location *	
Category	Supplemental			GPS Latitude/Longitude	
				Start	End
Item	DWR UCIP LMA Responsibility			39.501690 °	39.501690 °
				-122.006099 °	-122.006099 °
DWR ID					
Comment Code					
Inspector Comment					
FS_ID:14332 DS_ID:22944 EP_NO: N/A Repair Type: Non-Urgent Crossing Status: Found UCIP Comments: Appears abandoned and should be done so properly. FIELD_STRUCT_DESC: *ABANDONED* 8-inch drainage pipe of an unknown material sleeved through a 12-inch pipe of an unknown material through the levee, 9.5 feet below the crown. Flap gate located on the waterside (WS). Pipe open on the landside (LS). [Additional Reference(s): USACE Sacramento O&M Manual 140, May 1960, (HLM 2.27)]. FS Date: 5/29/2013

Pump at location of pipe on LS toe.

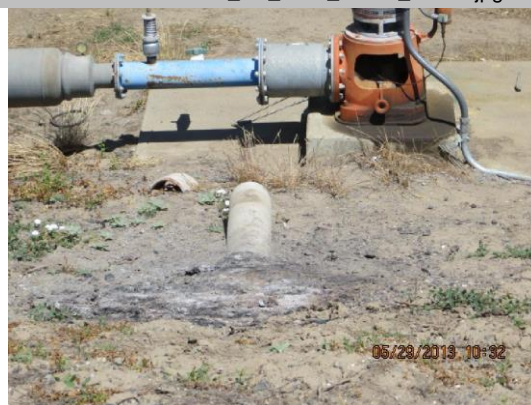
Photo 2 of 3 : UCIP\_SP\_2018\_14332\_23581.jpg

Pipe next to pump at LS toe.

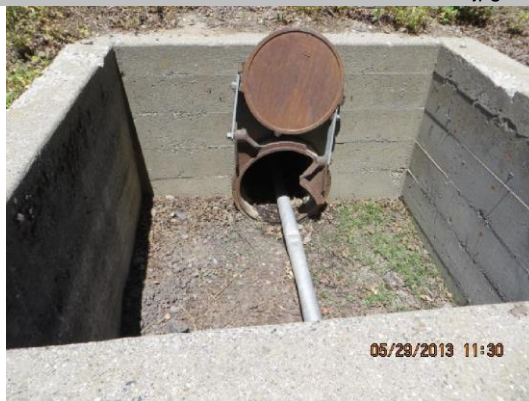
Photo 3 of 3 : UCIP\_SP\_2018\_51463\_27384.jpg

FS\_ID:51463  
DS\_ID:22904  
EP\_NO: 9572  
Repair Type: Urgent  
Crossing Status: Found  
UCIP Comments: 12/21/2016 Flap gate on WS does not appear to be broken however, flap gate does not fully close due to a 3-inch aluminum pipe sleeve through larger pipe. Need to remove 3-inch pipe in order to have WS flap gate close and to be compliant with Title 23. (O. Magana - DWR UCIP)05/29/2013 Broken flap gate and Concrete headwall on LS toe possibly tilting. Also a 3-inch alluminum irrigation line through the pipe. (W. Wylie - DWR UCIP)  
FIELD\_STRUCT\_DESC: 18-inch steel drainage pipe through the levee, 7.3 feet below the crown. Flap gate in 6-inch by 6-inch concrete box located on the waterside (WS) end. Concrete headwall located on the landside (LS) toe. (18-inch pipe [HLM 4.05] authorized under Automatic Board Order (ABO) issued as Permit No. 9572, 1974 - Henry and Annabel B. Smith). [Additional Reference(s): DWR Levee Log, 1992. USACE Sacramento O&M Manual 140, May 1960, (HLM 4.05)].

Distribution box on WS toe with broken flap gate and 3-inch aluminum irrigation pipe.

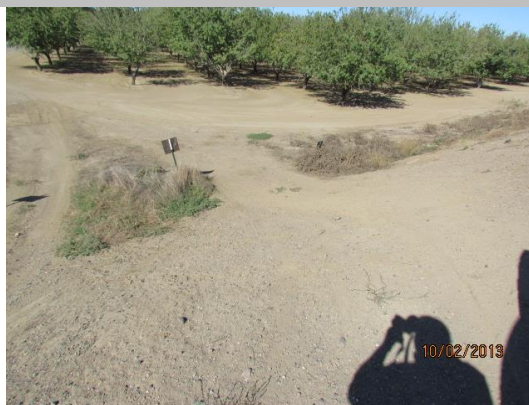
Photo 1 of 1 : SP\_2018\_LD0001G\_432\_57\_20180305\_00024.jpg

LM Start	<b>5.06</b>	Rating **	M	Issue No.	<b>57</b>
LM End	<b>5.06</b>	Issue Type +	Ma	Location *	LS
Category	Earthen Levee		GPS Latitude/Longitude		
			Start	End	
Item	Slope Stability		39.534593 °	39.534593 °	
			-121.995950 °	-121.995950 °	
DWR ID	DWR_LD0001G_01_f_2013_57

View of the vehicle erosion along the slope of the levee.

S3 : Repair the levee slope damaged by vehicle traffic and prevent access where possible.

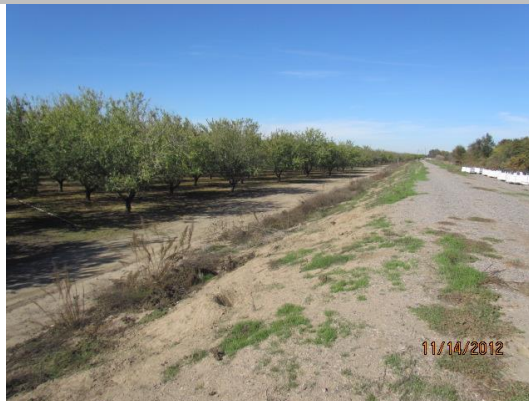
Photo 1 of 1 : SP\_2018\_LD0001G\_432\_7\_20180305\_00003.jpg

View of the rodent hole along the levee slope.

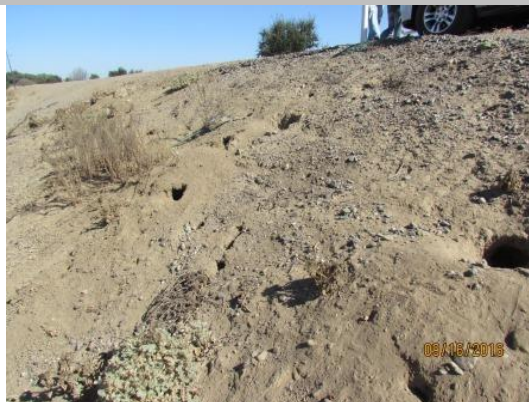
Photo 1 of 1 : SP\_2018\_LD0001G\_432\_67\_20180305\_00033.jpg

LM Start	5.22	Rating **	U	Issue No.	67	
LM End	5.22	Issue Type +	Ma	Location *	LS	
Category	Earthen Levee			GPS Latitude/Longitude		
				Start		End
Item	Animal Control			39.536750 °		39.536750 °
				-121.997090 °		-121.997090 °
DWR ID	DWR_LD0001G_01_s_2016_67					
Comment Code						
A1 : Exterminate rodents and backfill and compact or grout burrows.						
Inspector Comment						
Rodent holes on the LS slope need to be backfilled.

View of the rodent holes along the landside slope.

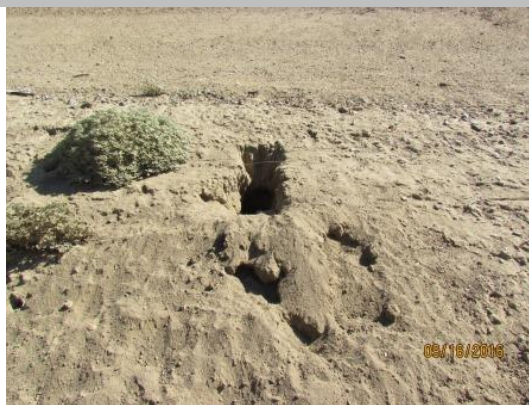
Photo 1 of 1 : SP\_2018\_LD0001G\_432\_75\_20180305\_00038.jpg

LM Start	5.55	Rating **	U	Issue No.	75
LM End	5.55	Issue Type +	Ma	Location *	LS
Category	Earthen Levee			GPS Latitude/Longitude	
				Start	End
Item	Animal Control			39.541110 °	39.541110 °
				-121.999348 °	-121.999348 °
DWR ID	DWR_LD0001G_01_f _ 2016_75				
Comment Code					
A1 : Exterminate rodents and backfill and compact or grout burrows.					
Inspector Comment					
Large rodent hole on the landside toe.

View of the rodent holes along the landside slope.

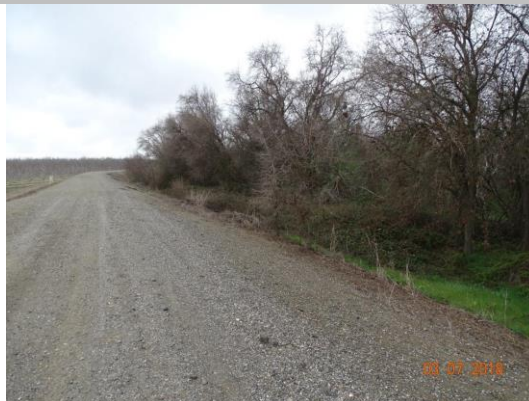
Photo 1 of 1 : SP\_2018\_LD0001G\_432\_68\_20180312\_00124.jpg

View of the vegetation along the waterside slope and toe.

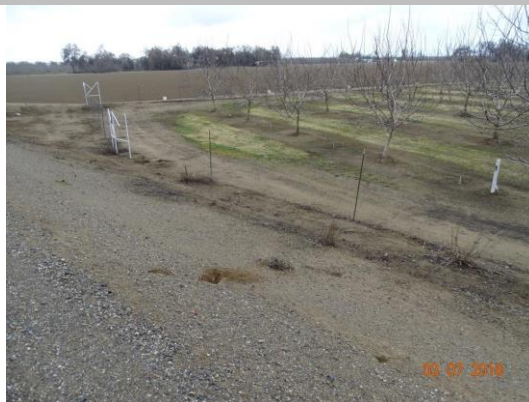
Photo 1 of 1 : SP\_2018\_LD0001G\_432\_70\_20180312\_00125.jpg

LM Start	5.77	Rating **	M	Issue No.	70
LM End	5.77	Issue Type +	Ma	Location *	LS
Category	Earthen Levee			GPS Latitude/Longitude	
				Start	End
Item	Animal Control			39.544087 °	39.544087 °
				-122.000863 °	-122.000863 °
DWR ID	DWR_LD0001G_01_s_2018_70				
Comment Code					
A3 : No rodents visible, but rodent burrows visible; need to backfill and compact or grout burrows.					
Inspector Comment					
Repair the rodent holes along the landside slope.

You of the rodent holes along the landside slope.

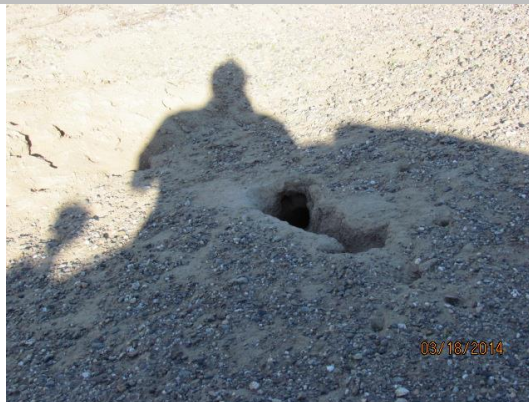
Photo 1 of 1 : SP\_2018\_LD0001G\_432\_47\_20180305\_00015.jpg

LM Start	6.22	Rating **	M	Issue No.	47
LM End	6.22	Issue Type +	Ma	Location *	LS
Category	Earthen Levee			GPS Latitude/Longitude	
				Start	End
Item	Animal Control			39.550533 °	39.550533 °
				-122.002319 °	-122.002319 °
DWR ID	DWR_LD0001G_01_s_2014_47				
Comment Code					
A3 : No rodents visible, but rodent burrows visible; need to backfill and compact or grout burrows.					
Inspector Comment

View of the rodent activity along the l/s slope.

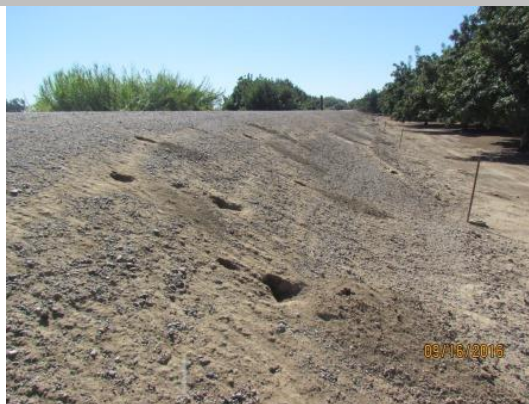
Photo 1 of 1 : SP\_2018\_LD0001G\_432\_76\_20180305\_00039.jpg

View of the rodent holes along the landside slope.

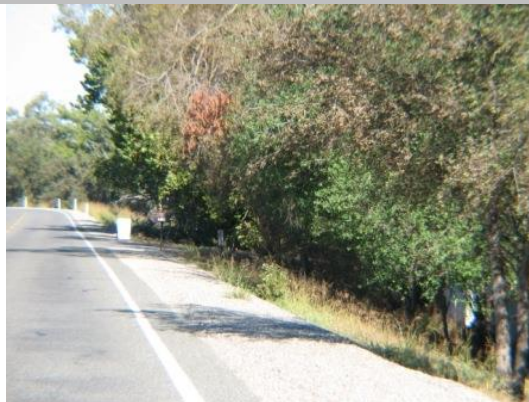
Photo 1 of 1 : SP\_2018\_LD0001G\_432\_20\_20180305\_00008.jpg

LM Start	8.05	Rating **	M	Issue No.	20
LM End	8.16	Issue Type +	Ma	Location *	WS
Category	Earthen Levee			GPS Latitude/Longitude	
				Start	End
Item	Trim / Thin Trees			39.576580 °	39.578187 °
				-122.004962 °	-122.005218 °
DWR ID	DWR_LD0001G_01_s_2012_20				
Comment Code					
T2 : Thin trees to allow visibility of the ground and room to flood fight.					
Inspector Comment

View of the trees and vegetation along the waterside slope of the levee.

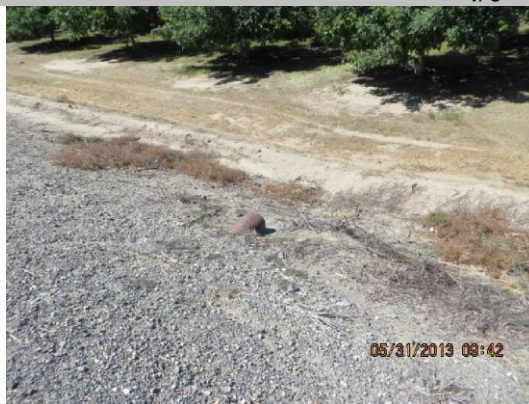
Photo 1 of 3 : UCIP\_SP\_2018\_51285\_23668.jpg

FS\_ID:51285  
DS\_ID:22918  
EP\_NO: 9563  
Repair Type: Urgent  
Crossing Status: Found  
UCIP Comments: 12/21/2016 same as last inspection crossing is opened on both ends and damaged on WS slope is visible. According to LMA representative, Nick Henning, pipe appears to be abandoned. (O. Magana - DWR UCIP)05/31/2013 Pipe open on both ends and damaged on WS slope. Pipe should be abandoned properly if appropriate. (W. Wylie - DWR UCIP)  
FIELD\_STRUCT\_DESC: \*ABANDONED\* 12-inch steel drainage pipe through levee, 5 feet below crown. Pipe open on both waterside (WS) and landside (LS) ends. One corrugated metal cutoff wall. (12-inch pipe [HLM 8.6] authorized under Automatic Board Order (ABO) No. 9563, 1974 - County of Glenn). [Additional Reference(s): DWR Levee Log, 1992. USACE Sacramento O&M Manual Unit 140, May 1960, (HLM 8.60)].  
FS Date: 12/21/2016

Pipe on LS slope.

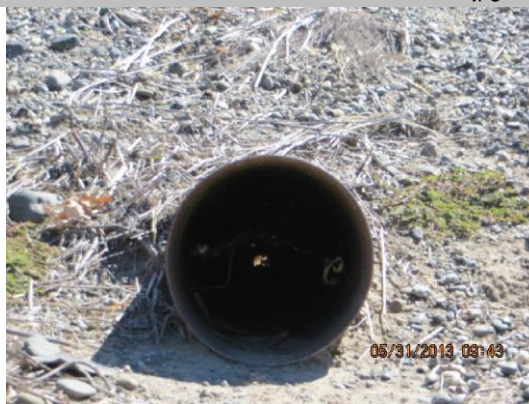
Photo 2 of 3 : UCIP\_SP\_2018\_51285\_23667.jpg

Pipe on LS slope.

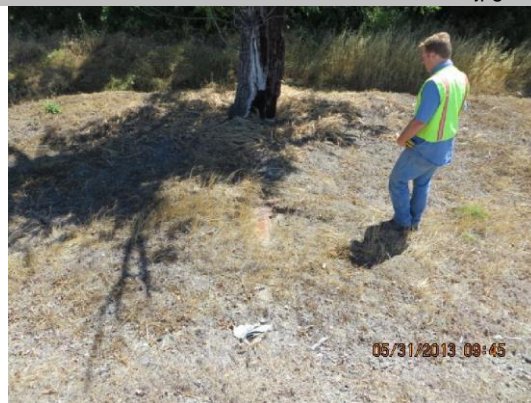
Photo 3 of 3 : UCIP\_SP\_2018\_51285\_23666.jpg

FS\_ID:51285  
DS\_ID:22918  
EP\_NO: 9563  
Repair Type: Urgent  
Crossing Status: Found  
UCIP Comments: 12/21/2016 same as last inspection crossing is opened on both ends and damaged on WS slope is visible. According to LMA representative, Nick Henning, pipe appears to be abandoned. (O. Magana - DWR UCIP)05/31/2013 Pipe open on both ends and damaged on WS slope. Pipe should be abandoned properly if appropriate. (W. Wylie - DWR UCIP)  
FIELD\_STRUCT\_DESC: \*ABANDONED\* 12-inch steel drainage pipe through levee, 5 feet below crown. Pipe open on both waterside (WS) and landside (LS) ends. One corrugated metal cutoff wall. (12-inch pipe [HLM 8.6] authorized under Automatic Board Order (ABO) No. 9563, 1974 - County of Glenn). [Additional Reference(s): DWR Levee Log, 1992. USACE Sacramento O&M Manual Unit 140, May 1960, (HLM 8.60)].  
FS Date: 12/21/2016

Pipe on WS slope.

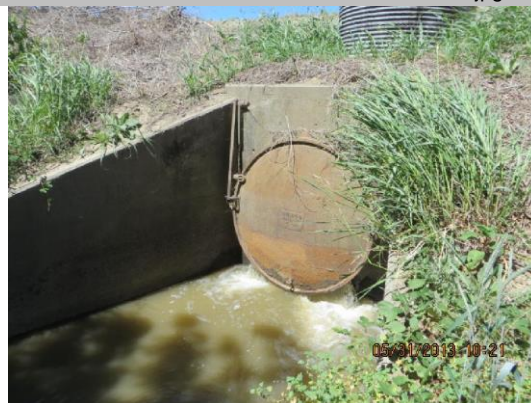
Photo 3 of 3 : UCIP\_SP\_2018\_14389\_23684.jpg

Comment Code						
Inspector Comment						
FS_ID:14389						
DS_ID:22920						
EP_NO: 9560						
Repair Type: Non-Urgent						
Crossing Status: Found						
UCIP Comments: Heavy rust along springline of pipe. Pipe has slight deformation at centerline of levee, not noticable on crown.						
FIELD_STRUCT_DESC: 72-inch corrugated metal drainage pipe through the levee, 15 feet below the crown. Flap gate located on the waterside (WS) end. Slide gate in 8-inch corrugated metal riser unit on the WS slope. Concrete headwalls on both ends. Two corrugated metal cutoff walls. (72-inch pipe [HLM 9.64]authorized under Automatic Board Order (ABO) issued as Permit No. 9560, 1974 - John and Lena Friesen). [Additional Reference(s): DWR Levee Log, 1992. USACE Sacramento O&M Manual 140, May 1960, (HLM 9.64)].						
FS Date: 5/31/2013

Flap gate and headwall on WS toe.

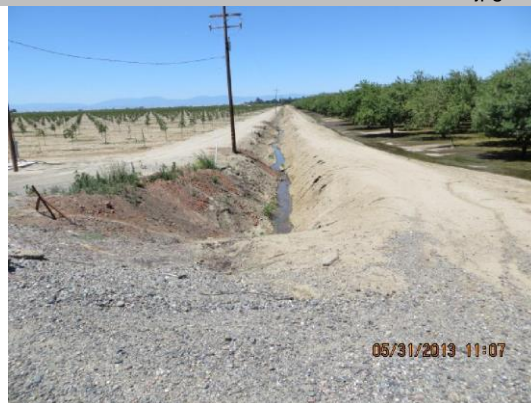
Photo 1 of 3 : UCIP\_SP\_2018\_51286\_24006.jpg

FS\_ID:51286  
DS\_ID:22924  
EP\_NO: 9556  
Repair Type: Urgent  
Crossing Status: Found  
UCIP Comments: 12/21/2016 same as last inspection flap gate disabled in open position. Surface erosion observed on LS slope. Recommend repair on WS flap gate to be able to close flap gate. (O. Magana - DWR UCIP)05/31/2013 Flap gate dissabled in open position. Pipe rusted through at WS toe upstream of Flapgate. (W. Wylie - DWR UCIP)  
FIELD\_STRUCT\_DESC: 24-inch corrugated metal drainage pipe through levee, 15 feet below crown. Flap gate is located on the waterside (WS) end. Slide gate is inside a corrugated metal pipe (CMP) riser located on the WS slope. Two CM cutoff walls. Concrete headwall is located on LS and under outlet at the WS toe. (24-inch pipe [HLM 10.59] authorized under Automatic Board Order (ABO) issued as Permit No. 9556, 1974 - E. R & M. R. Cooper). [Additional Reference(s): DWR Levee Log, 1992. USACE Sacramento O&M Manual Unit 140, May 1960, (HLM 10.59)].

Drainage channel on LS toe.

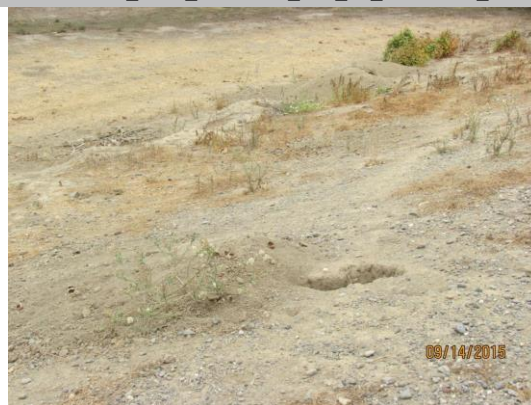
Photo 1 of 1 : SP\_2018\_LD0001G\_432\_66\_20180305\_00032.jpg

LM Start	11.10	Rating **	M	Issue No.	66
LM End	11.18	Issue Type +	Ma	Location *	WS
Category	Earthen Levee			GPS Latitude/Longitude	
				Start	End
Item	Animal Control			39.617252 °	39.618192 °
				-121.994605 °	-121.995609 °
DWR ID	DWR_LD0001G_01_f_2015_66				
Comment Code					
A3 : No rodents visible, but rodent burrows visible; need to backfill and compact or grout burrows.					
Inspector Comment					
Repair the rodent holes along the waterside slope.

View of the rodent holes along the waterside slope.

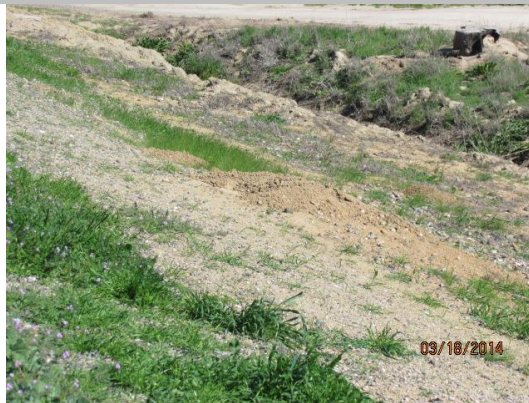
Photo 1 of 1 : SP\_2018\_LD0001G\_432\_48\_20180305\_00016.jpg

View of the rodent activity along the waterside slope.

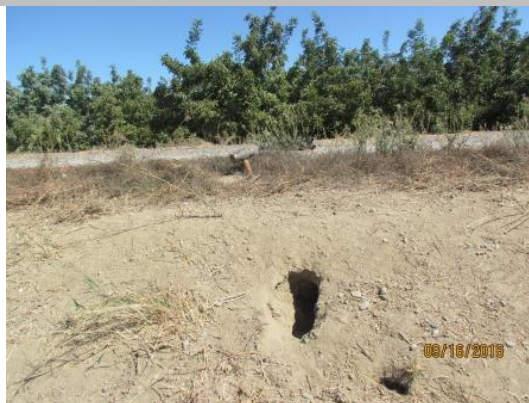
Photo 1 of 2 : SP\_2018\_LD0001G\_432\_79\_20180305\_00041.jpg

View of the rodent holes along the landside slope with large hammer sitting in the hole.

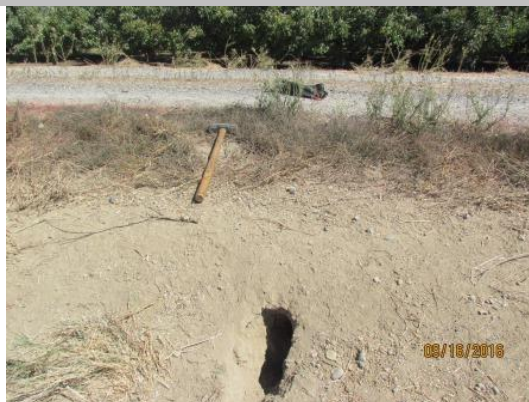
Photo 2 of 2 : SP\_2018\_LD0001G\_432\_79\_20180305\_00042.jpg

Another view of the rodent holes along the landside slope with a large hammer sitting next to the hole.

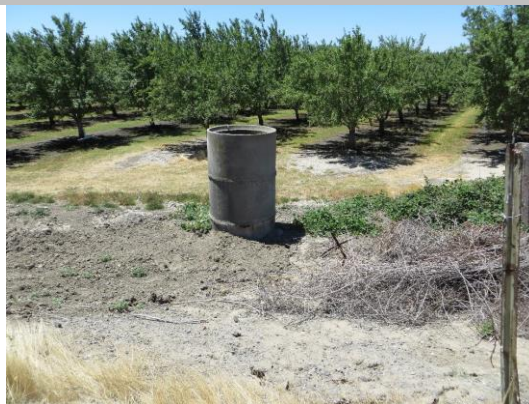
Photo 1 of 3 : UCIP\_SP\_2018\_14567\_24017.jpg

Comment Code						
Inspector Comment						
FS_ID:14567 DS_ID:22927 EP_NO: 9554 Repair Type: Non-Urgent Crossing Status: Found UCIP Comments: Erosion and sloughing on LS slope possibly due to rodent activity in area. FIELD_STRUCT_DESC: 24-inch corrugated metal drainage pipe through the levee, 11 feet below the crown. Slide gate in 36-inch corrugated metal riser unit on the waterside (WS) slope. 48-inch concrete standpipe on the landside (LS) toe. Two corrugated metal cutoff walls. (24-inch pipe [HLM 11.93] authorized under Automatic Board Order (ABO) issued as Permit No. 9554, 1974 - Thomas H. Reed). [Additional Reference(s): DWR Levee Log, 1992. USACE Sacramento O&M Manual 140, May 1960, (HLM 11.93)]. FS Date: 5/31/2013

Concrete standpipe on LS toe.

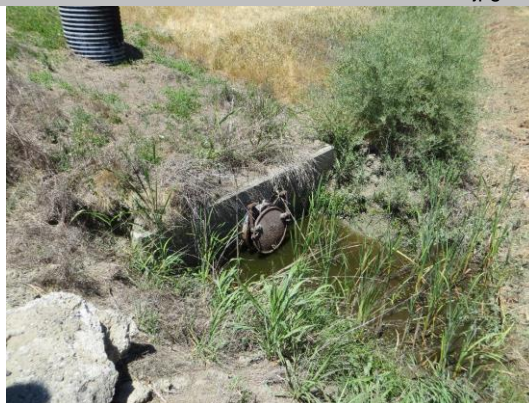
Photo 3 of 3 : UCIP\_SP\_2018\_14569\_24024.jpg

Item	DWR UCIP LMA Responsibility			39.626918 °	39.626918 °	
				-122.001421 °	-122.001421 °	
DWR ID						
Comment Code						
Inspector Comment						
FS_ID:14569						
DS_ID:22928						
EP_NO: 9554						
Repair Type: Non-Urgent						
Crossing Status: Found						
UCIP Comments: Flap gate heavily corroded. Good candidate for video inspection. Vegetation interfering with inlet.						
FIELD_STRUCT_DESC: 24-inch corrugated metal drainage pipe through the levee, 7 feet below the crown. Flap gate on the waterside (WS) end. Slide gate in 36-inch corrugated metal pipe riser unit on the WS slope. Concrete headwalls on both ends. Two corrugated metal cutoff walls. (24-inch pipe [12.04] authorized under Automatic Board Order (ABO) issued as Permit No. 9554, 1974 - Thomas H. Reed). [Additional Reference(s): DWR Levee Log, 1992. USACE Sacramento O&M Manual 140, May 1960, (HLM 12.04)].						
FS Date: 5/31/2013

Headwall and flapgate on WS toe.
